SILICON NITRIDE IN ROLLING CONTACT BEARINGS

NORTON Co.

PREPARED FOR  
NAVAL AIR SYSTEMS COMMAND

FINAL REPORT  
Contract N00019-73-C-0193  
January 3, 1973 to October 3, 1973

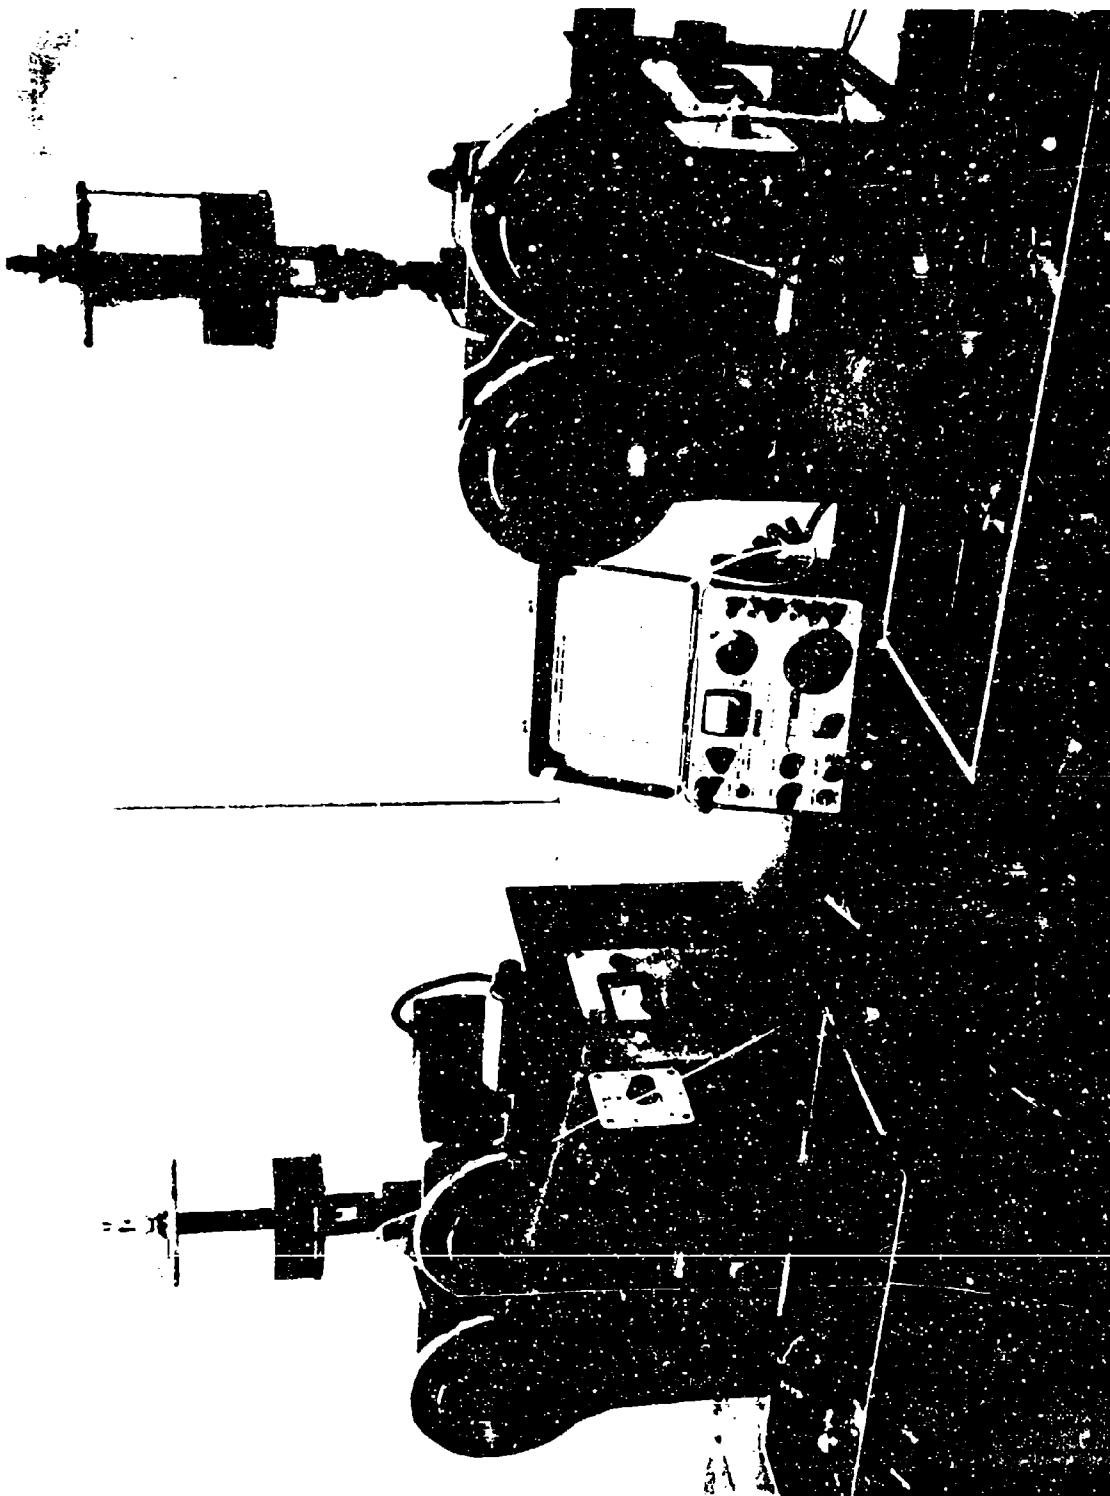
The Rolling Contact Fatigue test machine developed by General Electric Company and marketed by Polymet Corporation is shown in Figure 1. Two discs, seven inches in diameter and one-half inch thick, are pressed against the rotating test specimen. The discs have a crown radius of 0.250 inches. The test specimen is a three inch long straight cylinder with a diameter of 0.375 inches. With this geometrical configuration, the contact stresses can be calculated (in the non-lubricated condition) for a given load, as is shown in Appendix II. For example, for a load of 325 pounds, the maximum Hertz stress developed between a steel test specimen and steel loading wheels is 700,000 psi. The load necessary to produce this stress in a silicon nitride specimen with a steel wheel is approximately 15 percent less because of the higher modulus of elasticity of the ceramic.

FIGURE 1 - Rolling Contact Fatigue Test Machines

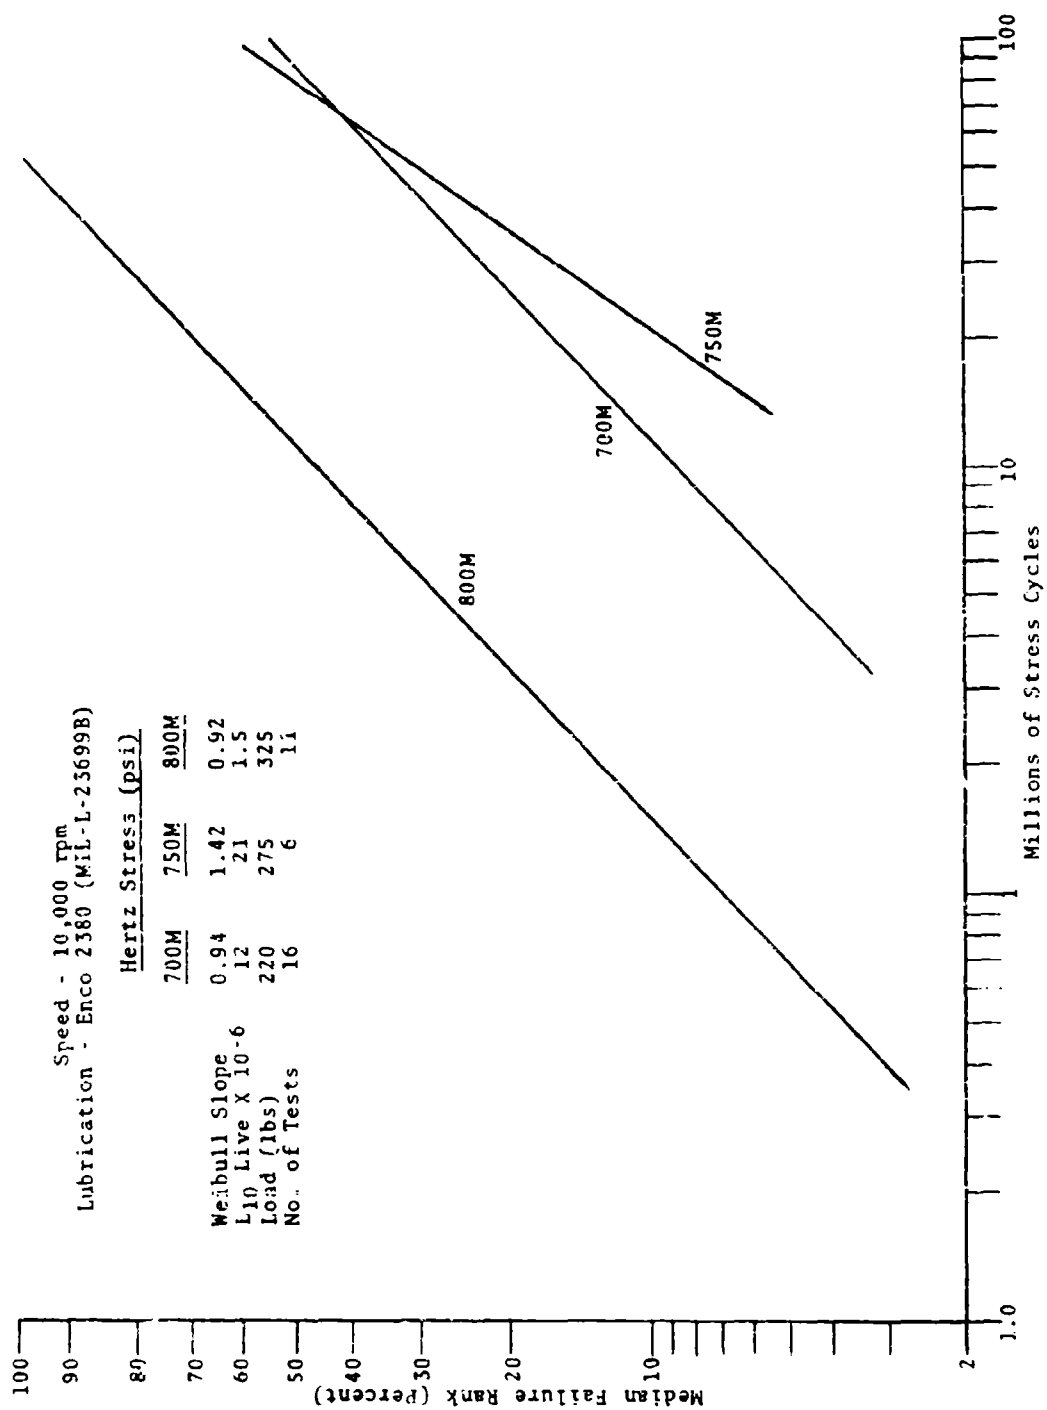
FIGURE 5 - RCF Test Results on Silicon Nitride vs. Load

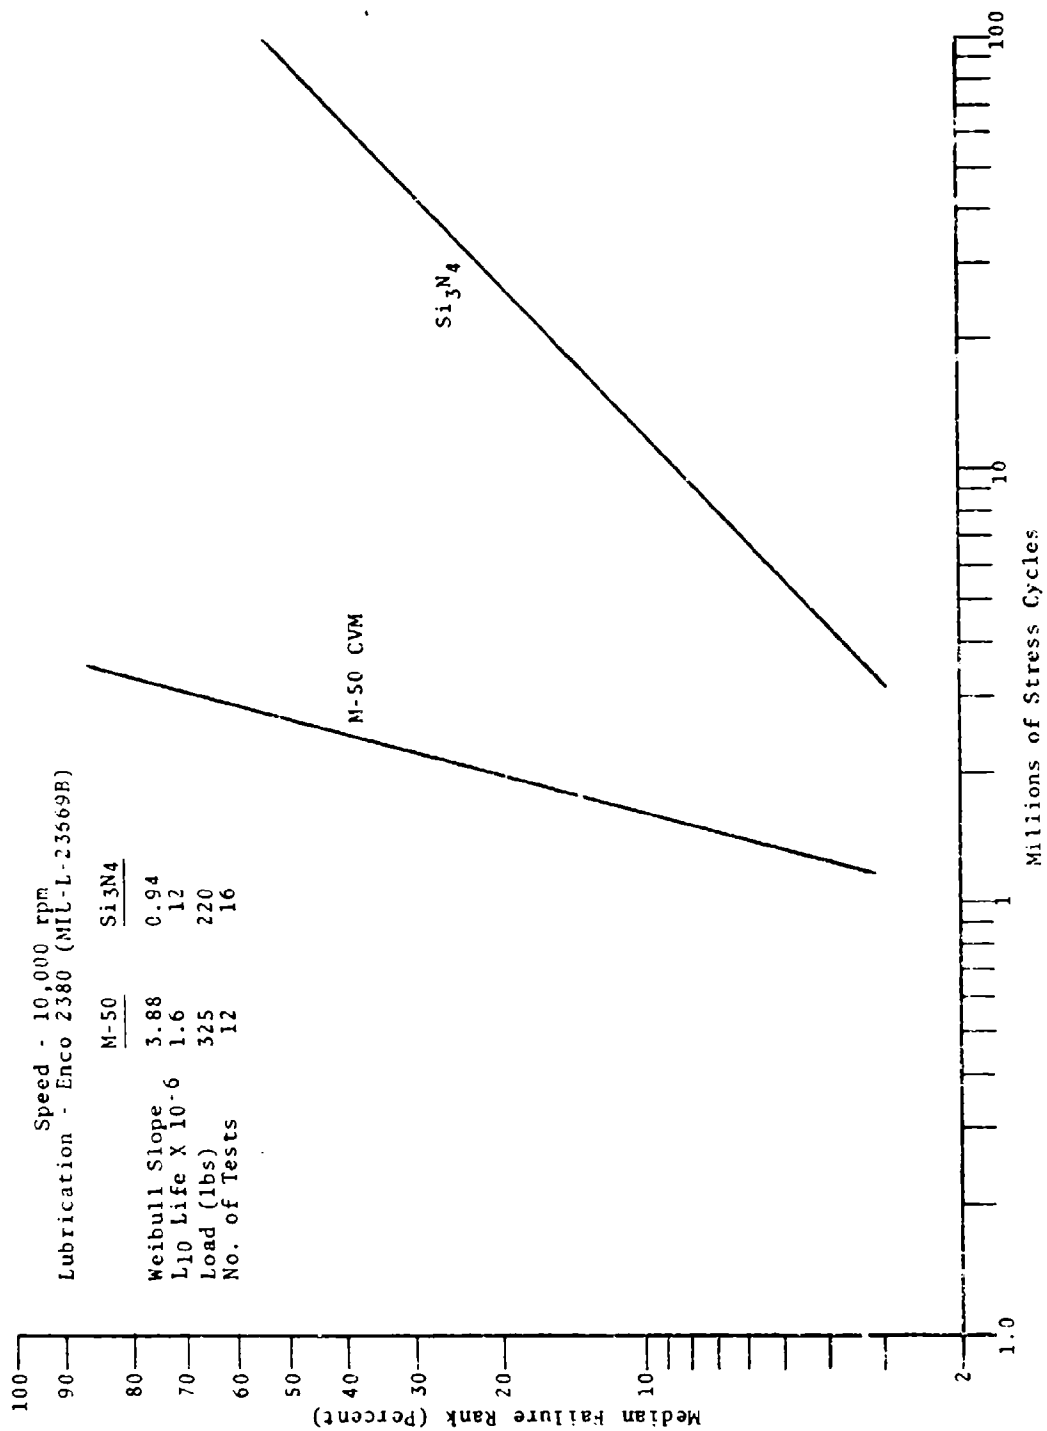
FIGURE 6 - RCF Test Results on Silicon Nitride  
and M-50 CVM at 700 M psi Hertz Stress

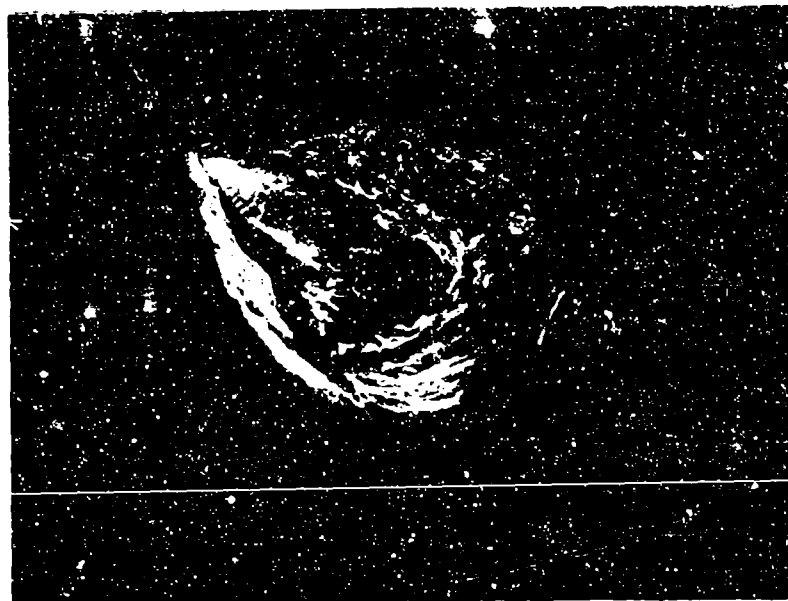
FIGURE 9 - Typical Fatigue Spall on Rod 73-17, SEM, 50X.

Figure 9 shows another example of a typical edge initiated spall. In this case Hertzian cracking is evident, often in the form of shallow arcs which do not penetrate far into the load zone. Figure 10 shows an example of a spall which is believed not to have initiated from the edge of the load zone, but rather from inside the zone near 0 and at the surface. Although not readily visible in the photograph, Hertz cracks were present nearby.

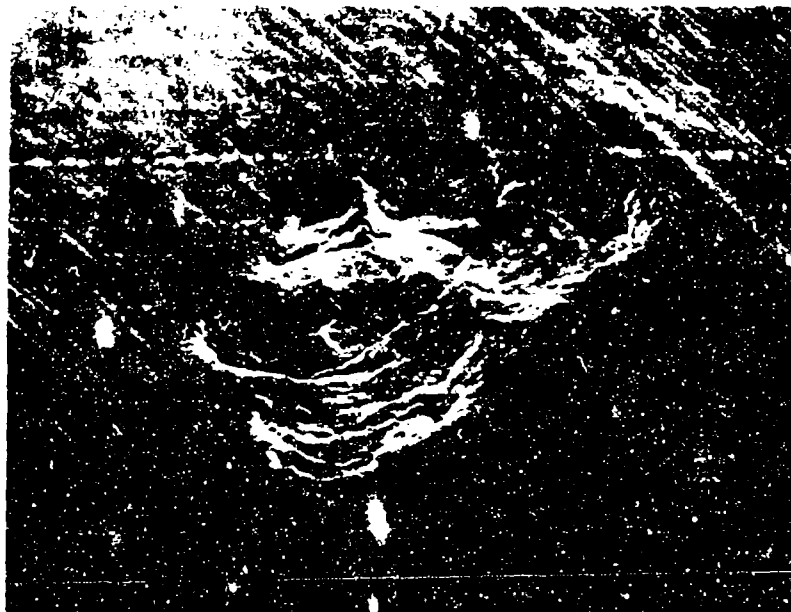
FIGURE 10 - Rare, Within Track Initiated Spall on Rod 73-9, SEM, 100X.

No inclusion was found to be associated with Figure 10, nor with any spall origin on this rod. Through electron probing of the area of the spalls initiated inside the load track or at the edge of the load track on NC-132 silicon nitride rods is in contrast to the results obtained on HS-110 silicon nitride rods<sup>1</sup>. This is due to the greater microstructural uniformity of the NC-132

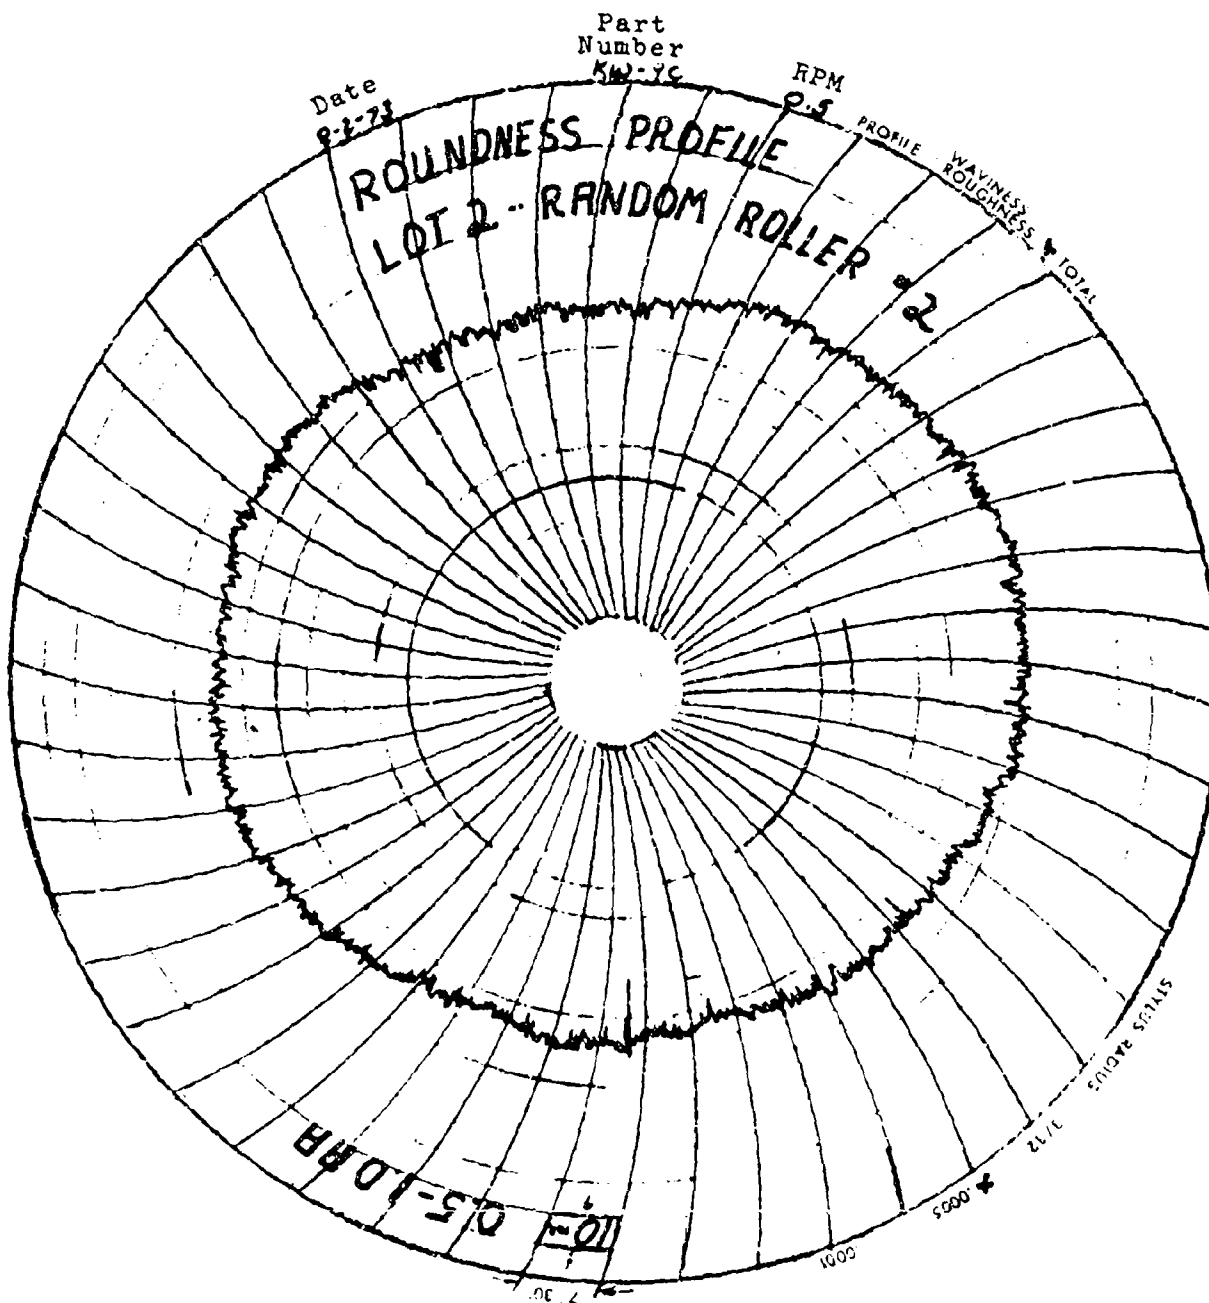
A sampling of the 120 finished and sized blanks was made for diameter and specific crown characteristics (see Table XII). A typical rotary proficording of a sample roller is shown in Figure 23. Overall, the rollers are to print tolerances with the exception of the maximum diameter variation within a group of 20 rollers and crown flat taper. The diameters are measured at the center of the roller lengths. Within one group, the diameter of two rollers differ by as much as 115 millionths of an inch from the low diameter of one to the high diameter of the other. However, if the average diameters of each respective roller are considered, the maximum variation is within the 50 millionths of an inch allowed.

FIGURE 23 - Rotary Profilcording of a Typical  
Finished Silicon Nitride Roller

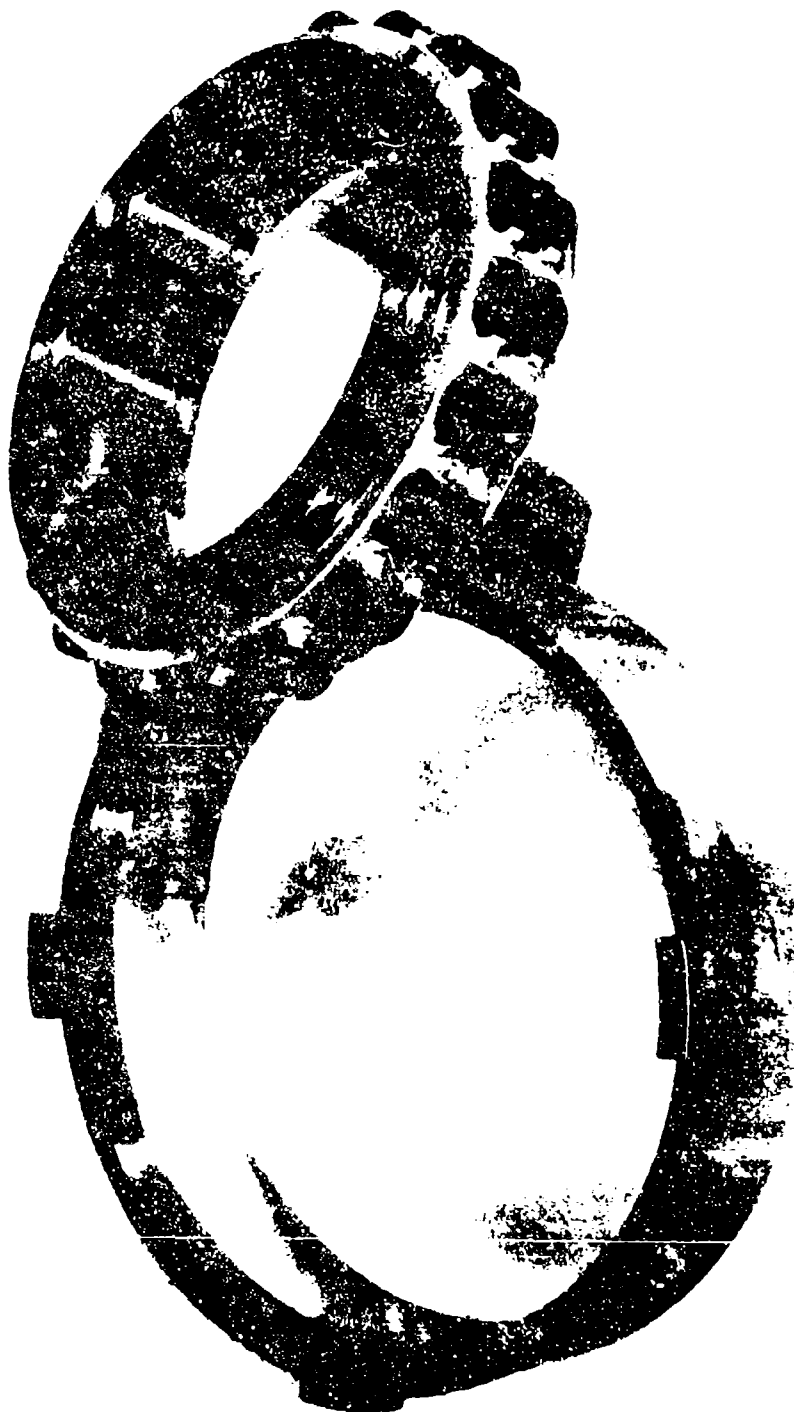
FIGURE 26 - Bearing Containing Silicon Nitride Rollers  
and Steel Races.

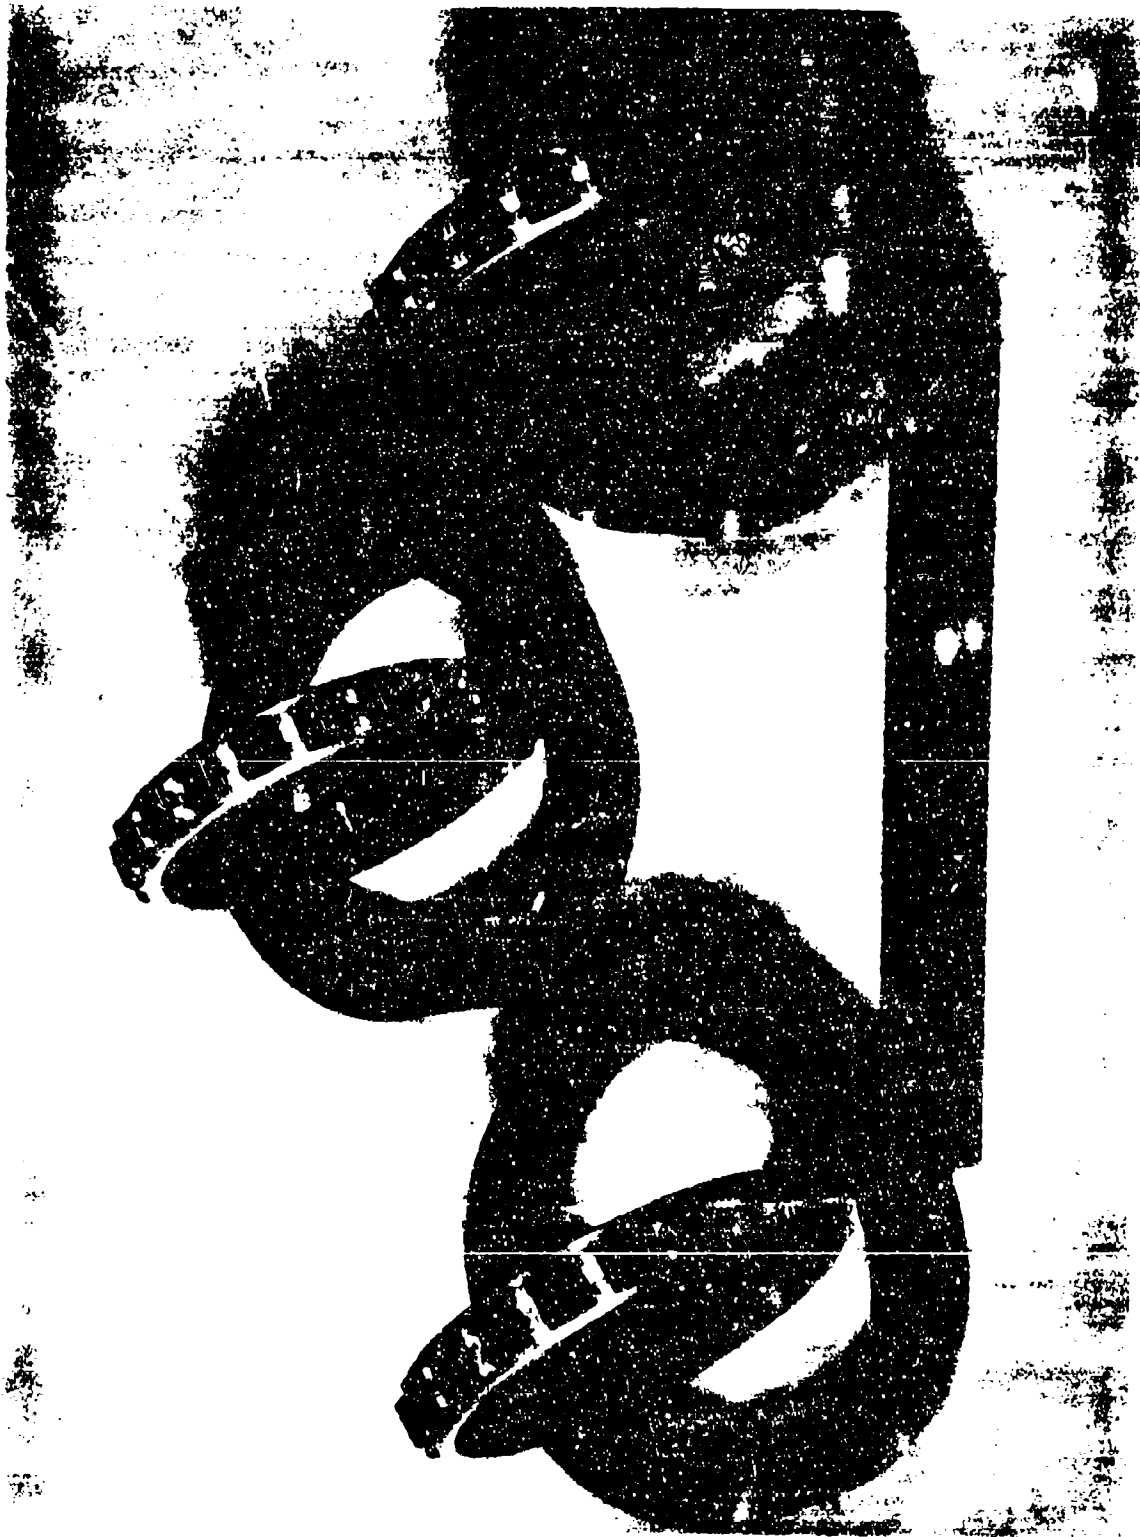
Three bearings with silicon nitride races and rollers were fabricated with AISI 4340 steel retainers and are shown in Figure 29. A close-up is shown in Figure 30. The bearings are serialized 1, 2 and 3. The measured diametral clearances of the three were within the tolerance range of 0.001 to 0.002 inch.

FIGURE 29 - Bearings with Silicon Nitride Rollers and Races

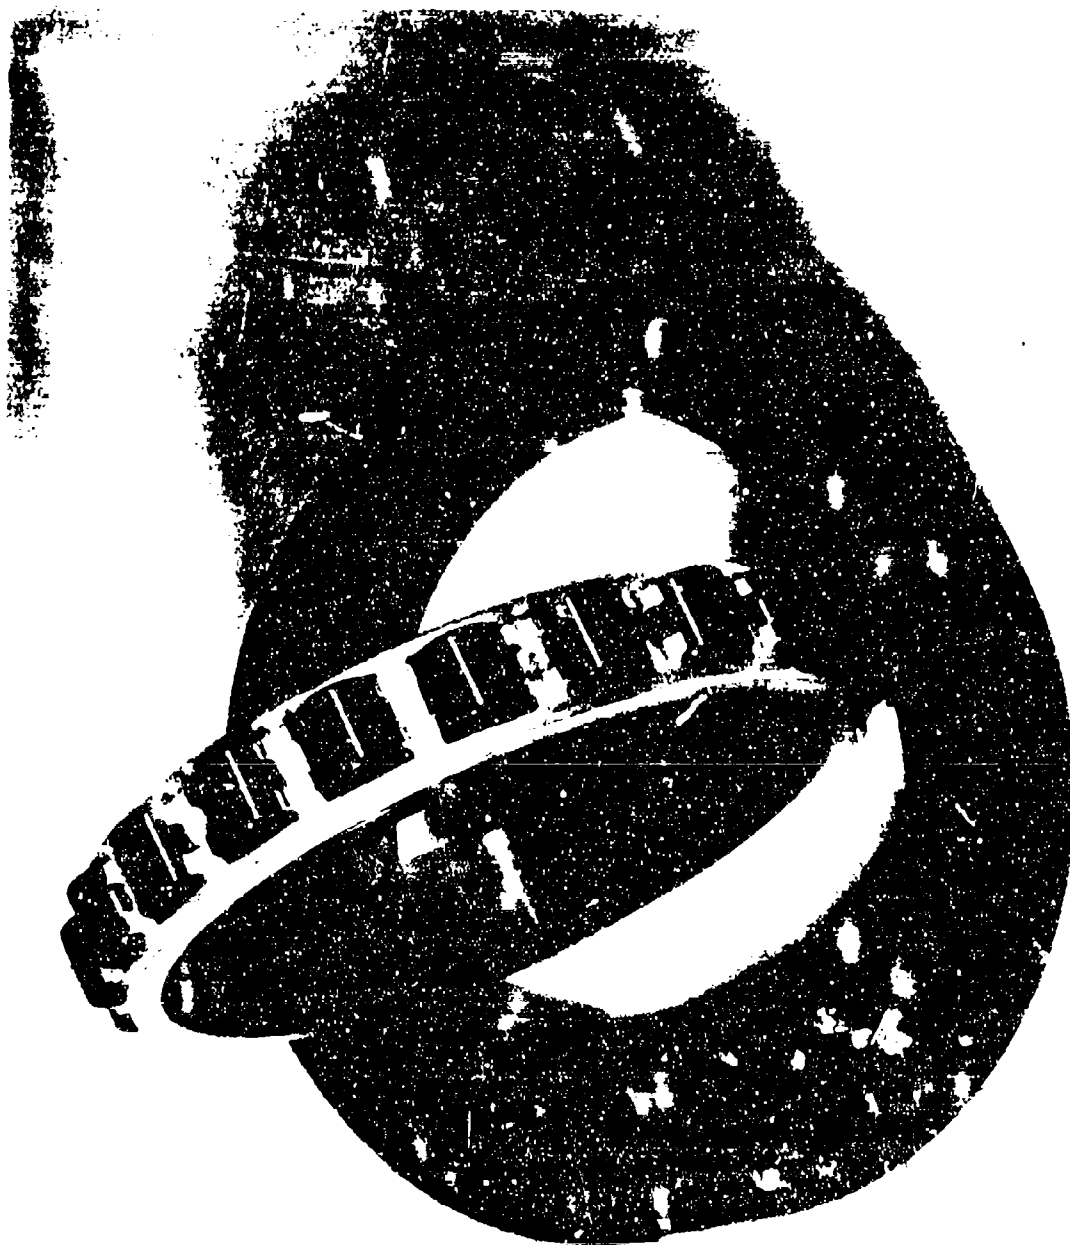
FIGURE 30 - Bearing with Silicon Nitride Rollers and Races

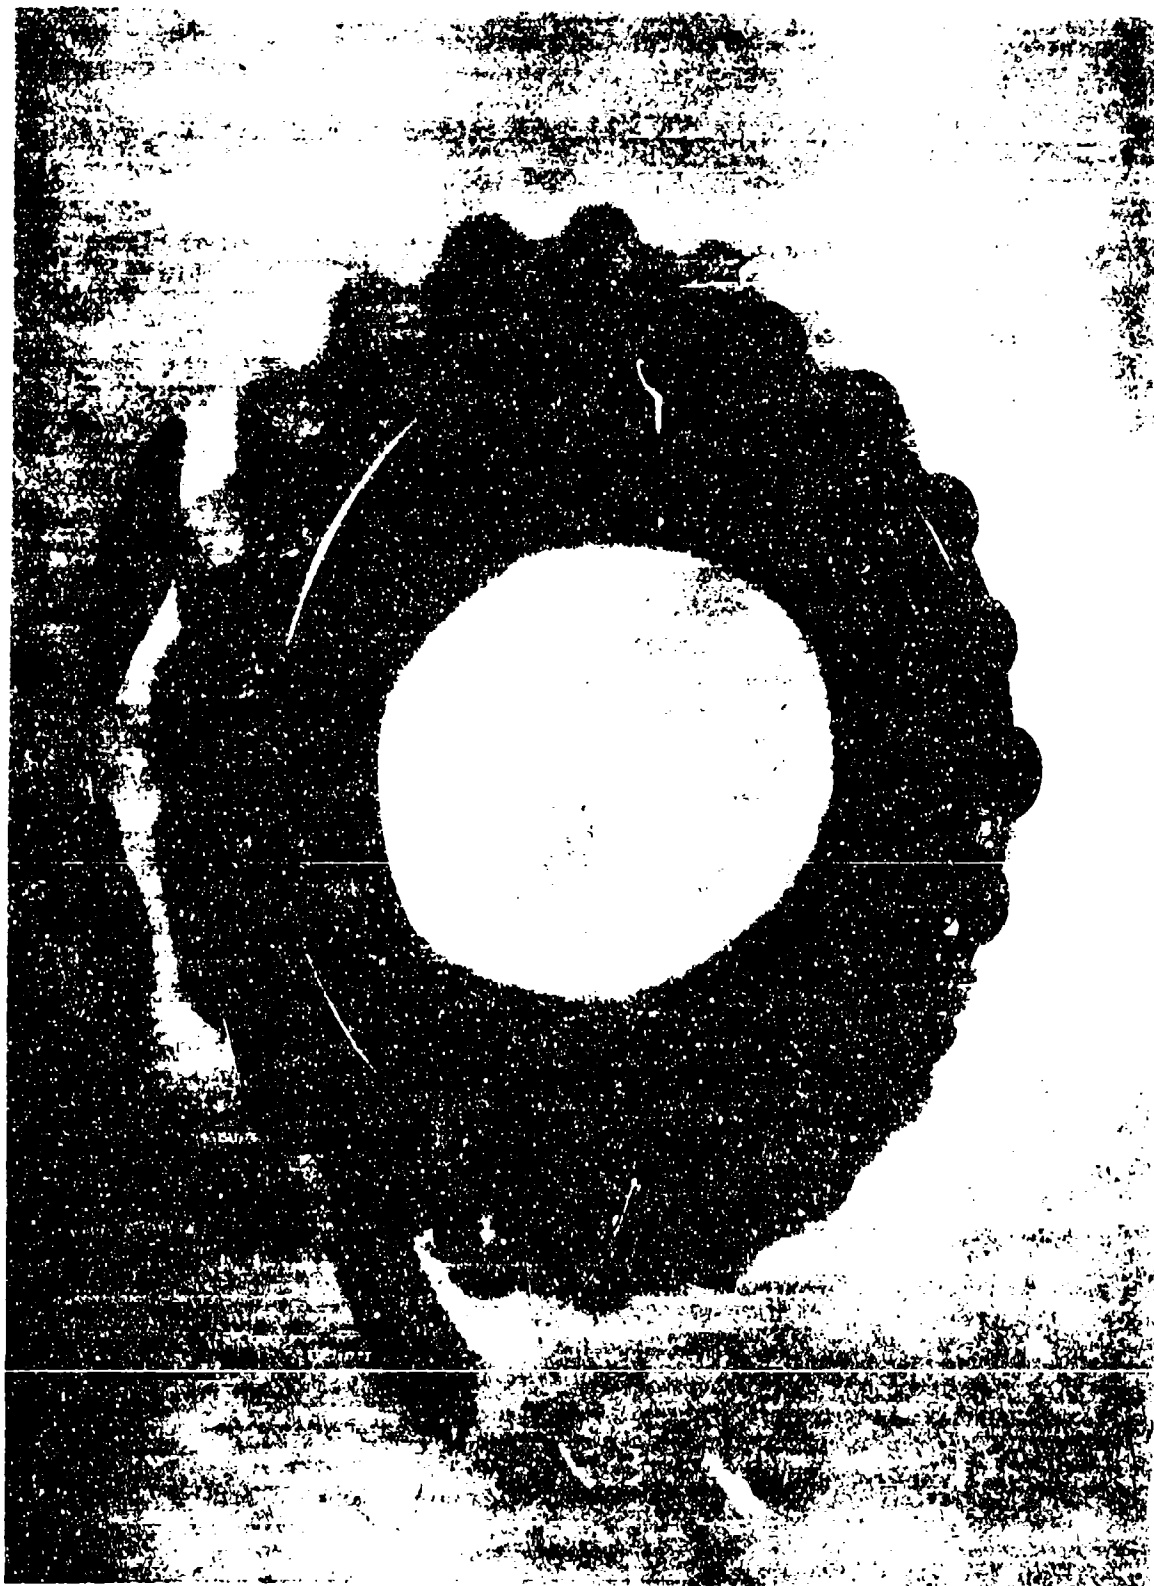
FIGURE 38 - Damaged Silicon Nitride Bearing, Chipped During Disassembly

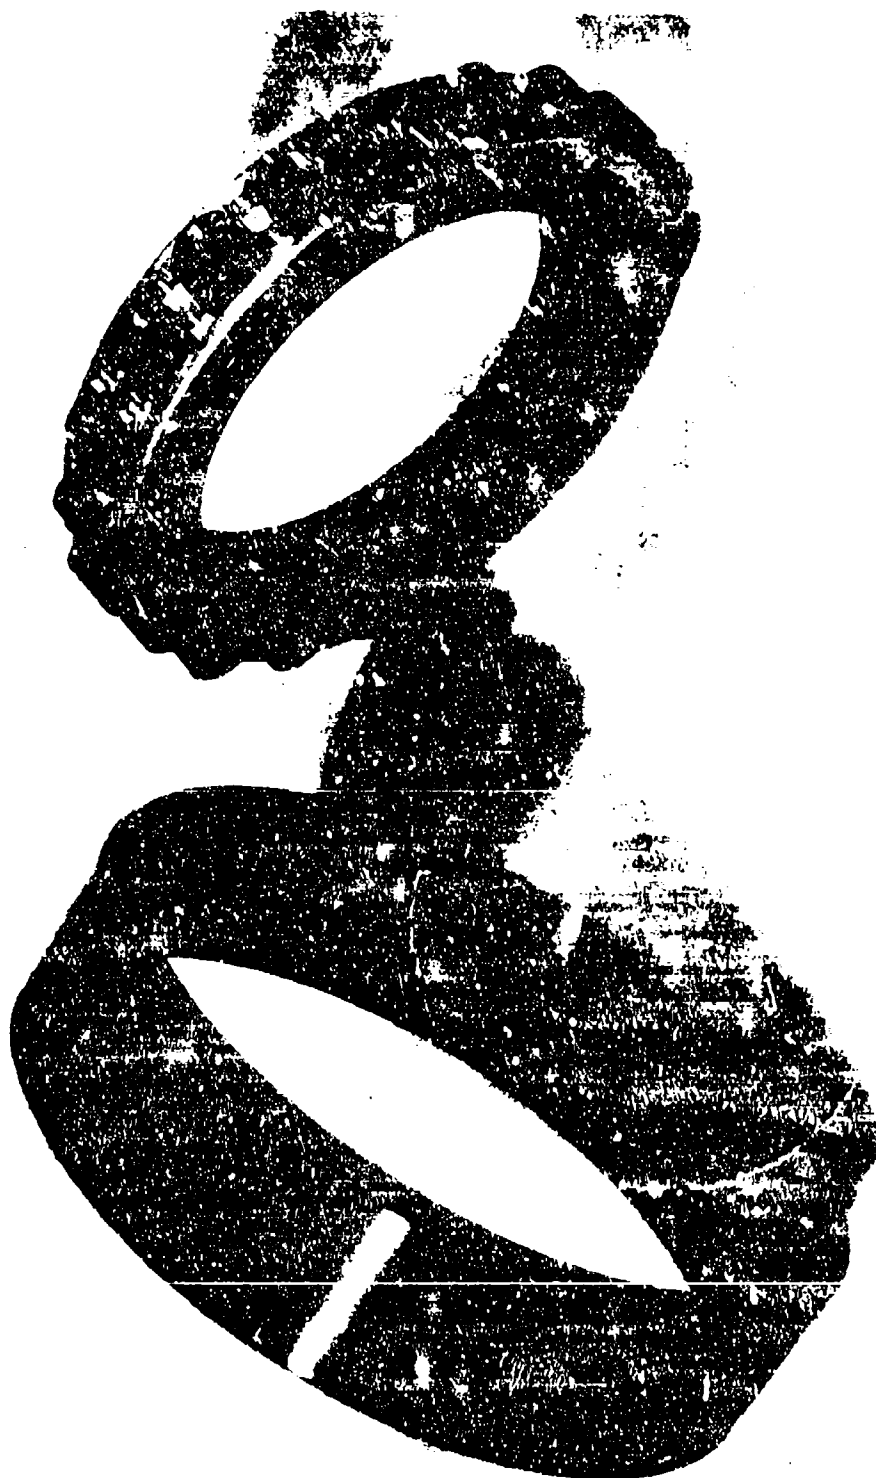
FIGURE 39 - Silicon Nitride Race Bearing Suspended at 331 Hours
